NPIC/R-1523/63

SUPPLEMENT TO IPIRS ON BRASS KNOB MISSIONS 3743 & 3745

ASSESSMENT OF HURRICANE FLORA DAMAGE IN SELECTED AREAS OF CUBA

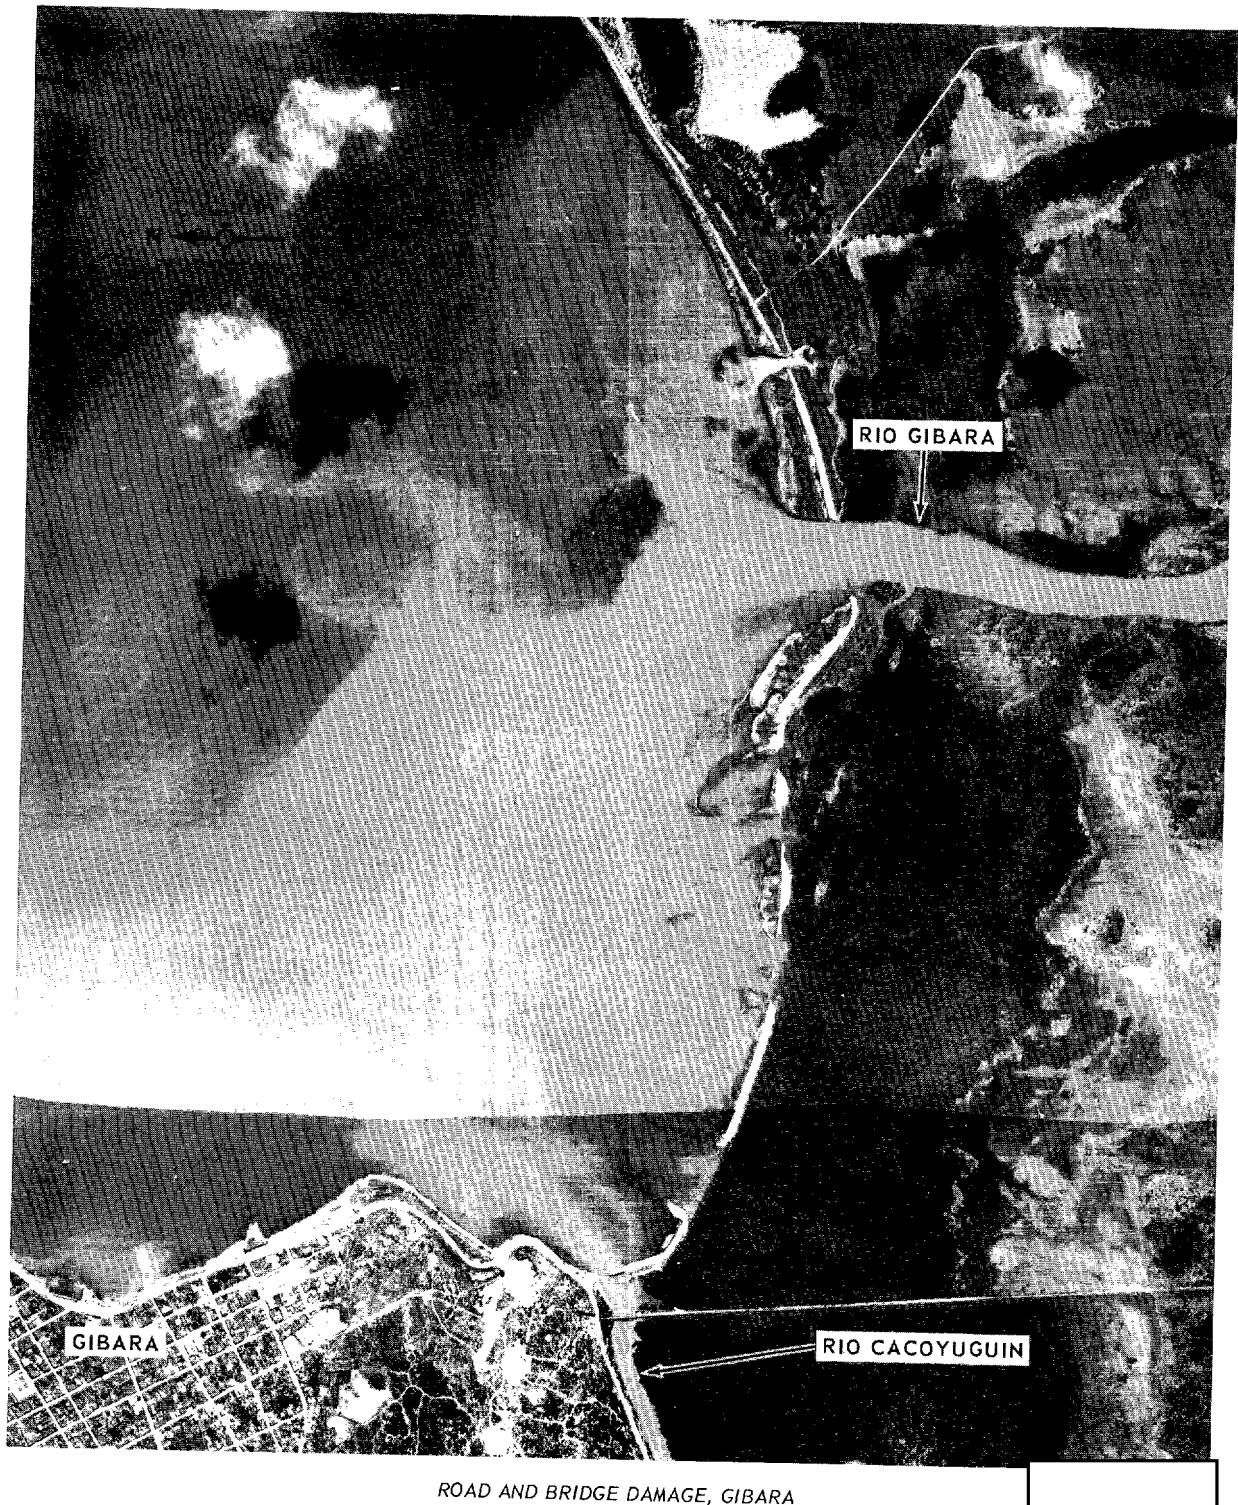
NPIC/R-1523/63
ATTACHMENT 1

HURRICANE FLORA HAS CAUSED CONSIDERABLE FLOODING IN THE PLAINS AREAS NORTH OF THE SIERRA MAESTRA RANGE AND ALONG THE NORTHERN COASTAL AREAS OF CAMAGUEY AND ORIENTE PROVINCES. ROADS, RAILROADS, AND BRIDGES IN AREAS SOUTH OF GIBARA HAVE SUFFERED CONSIDERABLE DAMAGE (SEE ATTACHMENT 1). EXTENSIVE HIGHWAY WASHOUT WAS OBSERVED BETWEEN UTM COORDINATES 18Q UT 457725 AND 18Q UT 527828 (AMS SERIES E723, SHEET 4977IV, 1ST ED). A HOUND HELICOPTER WAS OBSERVED IN FLIGHT OVER A FLOODED SECTION OF THE HIGHWAY AT 18Q UT 515817 (SEE ATTACHMENT 2).

ROAD AND BRIDGE DAMAGE, GIBARA

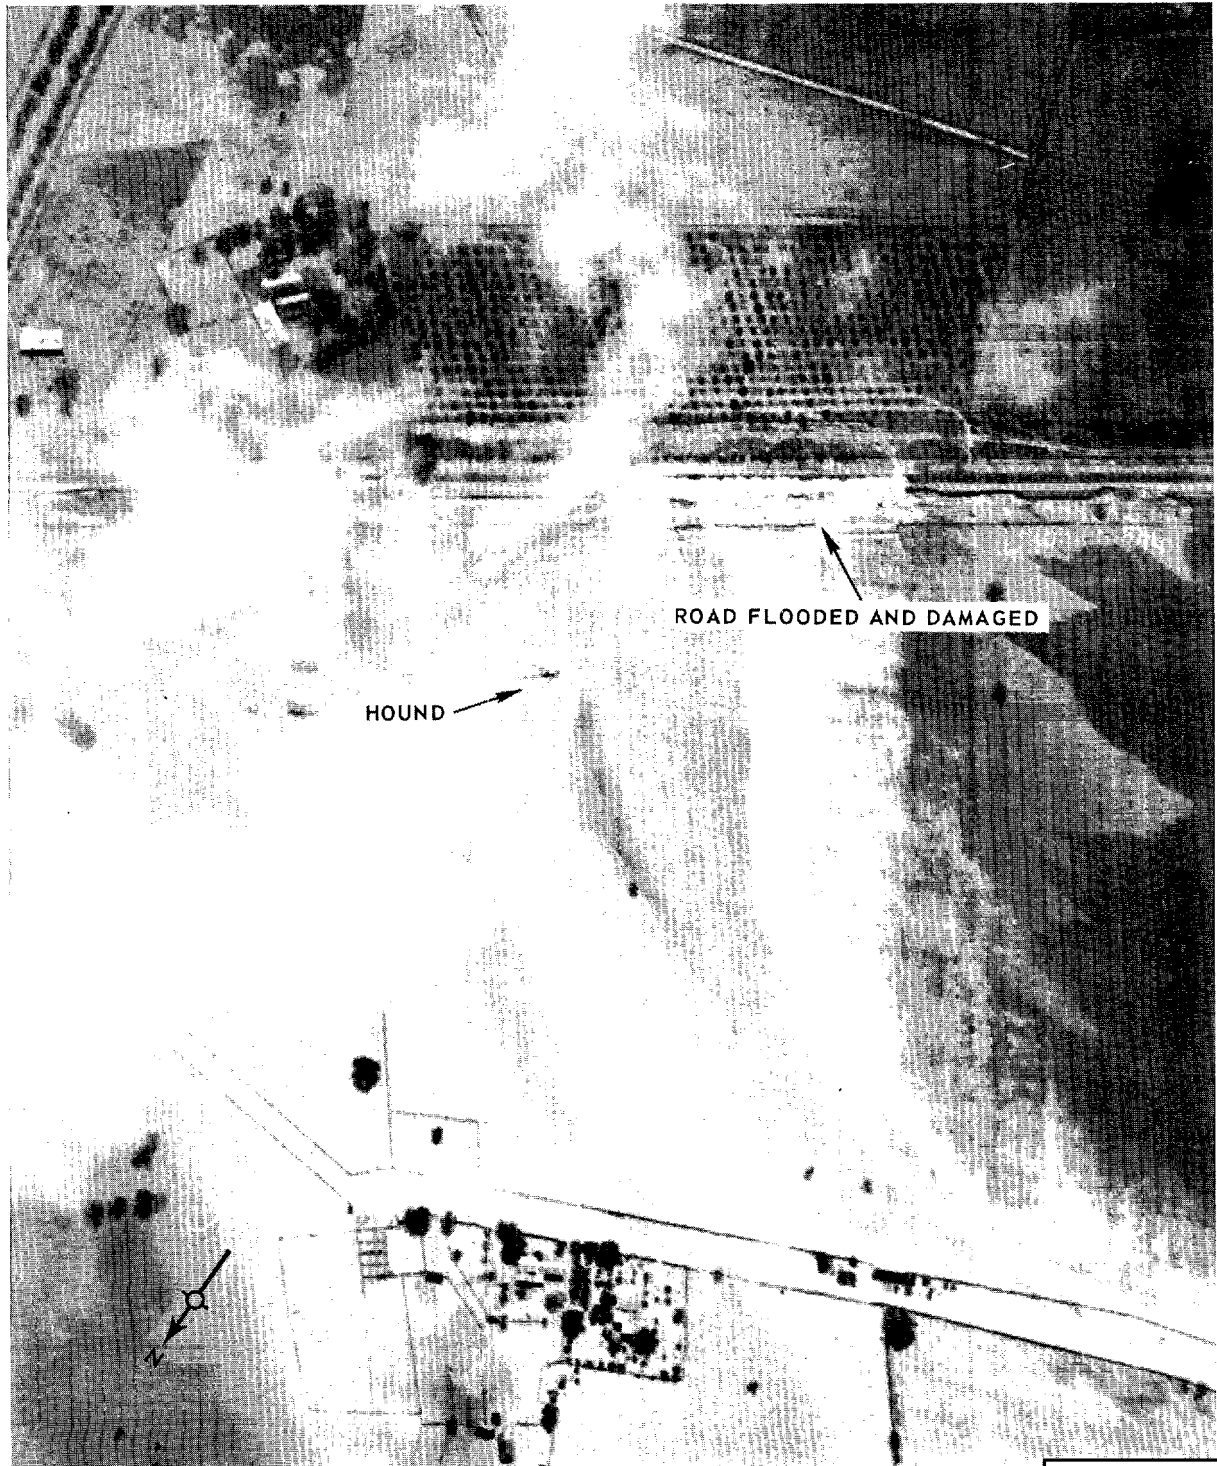
NPIC/R-1523/63
ATTACHMENT 2

ROAD DAMAGE APPROXIMATELY 17 NM SSW OF HOLGUIN

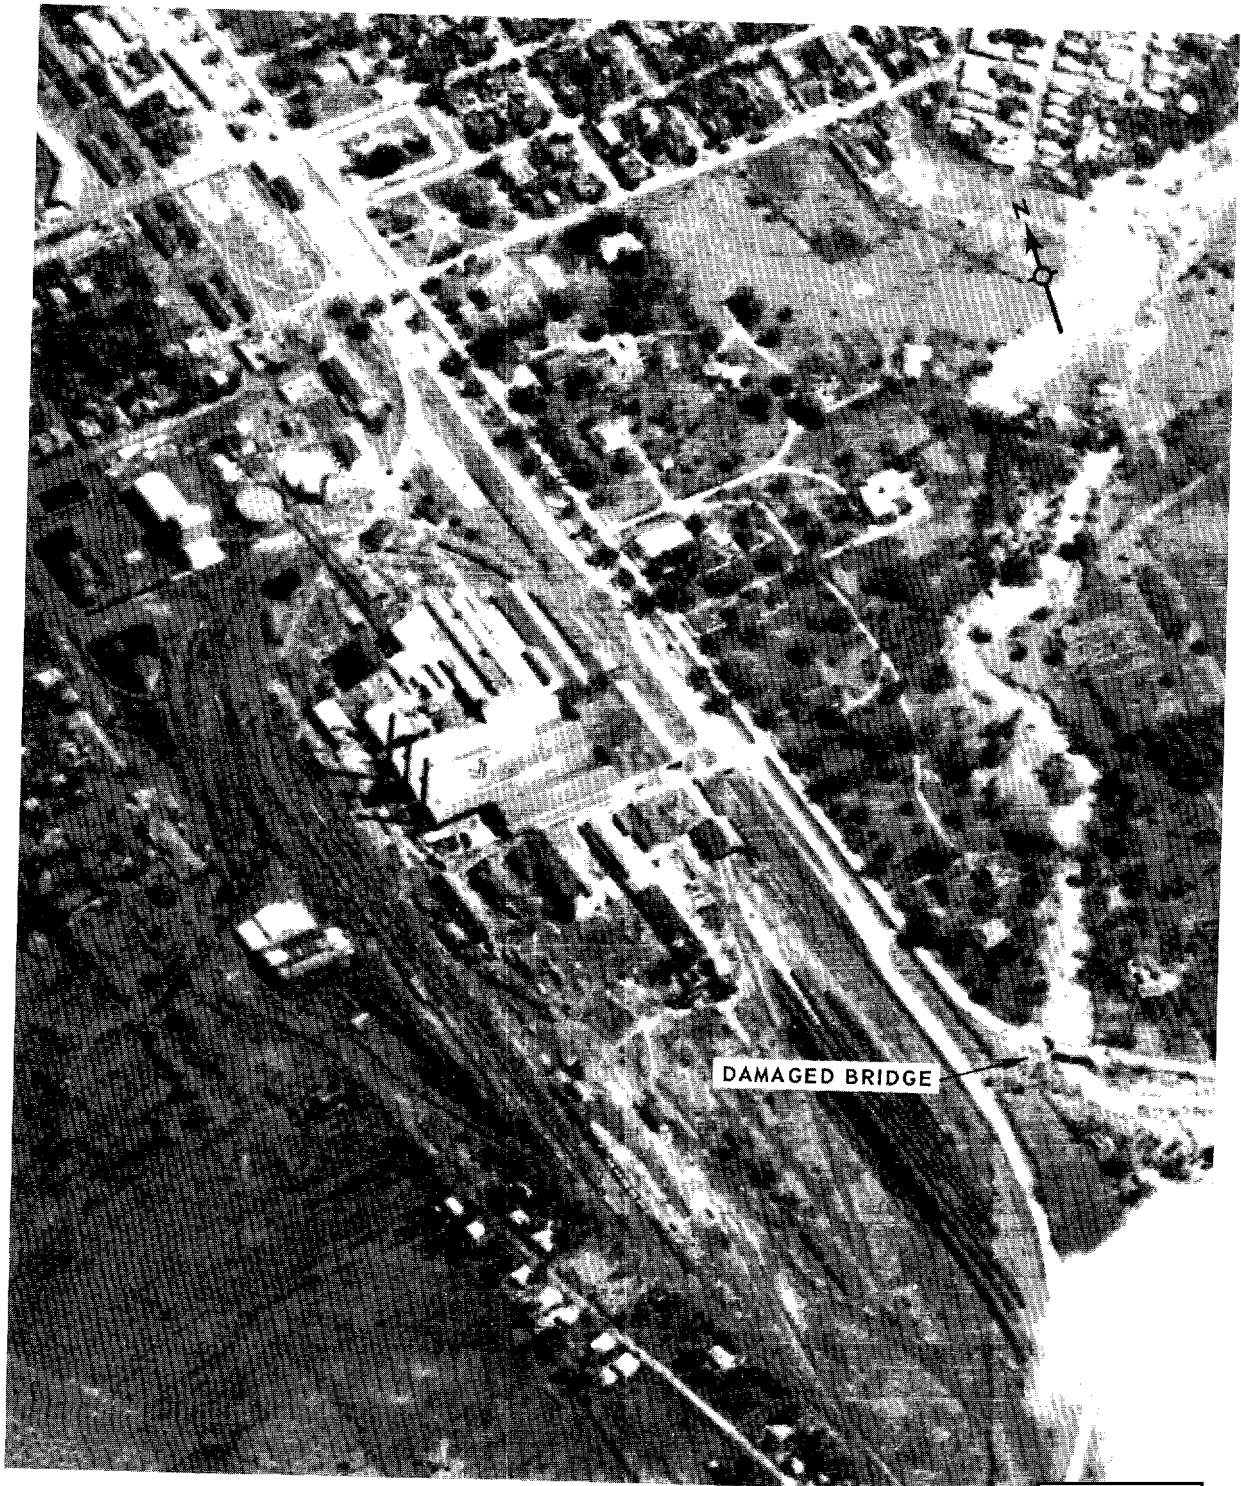
NPIC/R-1523/63
ATTACHMENT 3

NO DAMAGE OBSERVED AT THE SUGAR MILL, HOWEVER,
SEVERE DAMAGE WAS OBSERVED AT THE HIGHWAY BRIDGE
OVER THE RIO SAUTA MARIA .2 NM SOUTH OF THE MILL AT
UTM 18Q UU379412. (AMS E723, SHEETS 4879-I AND
4879-II, 1ST ED).
(SEE ATTACHMENT 3).

ANTONIO GUITERAS (DELICIAS) SUGAR MILL

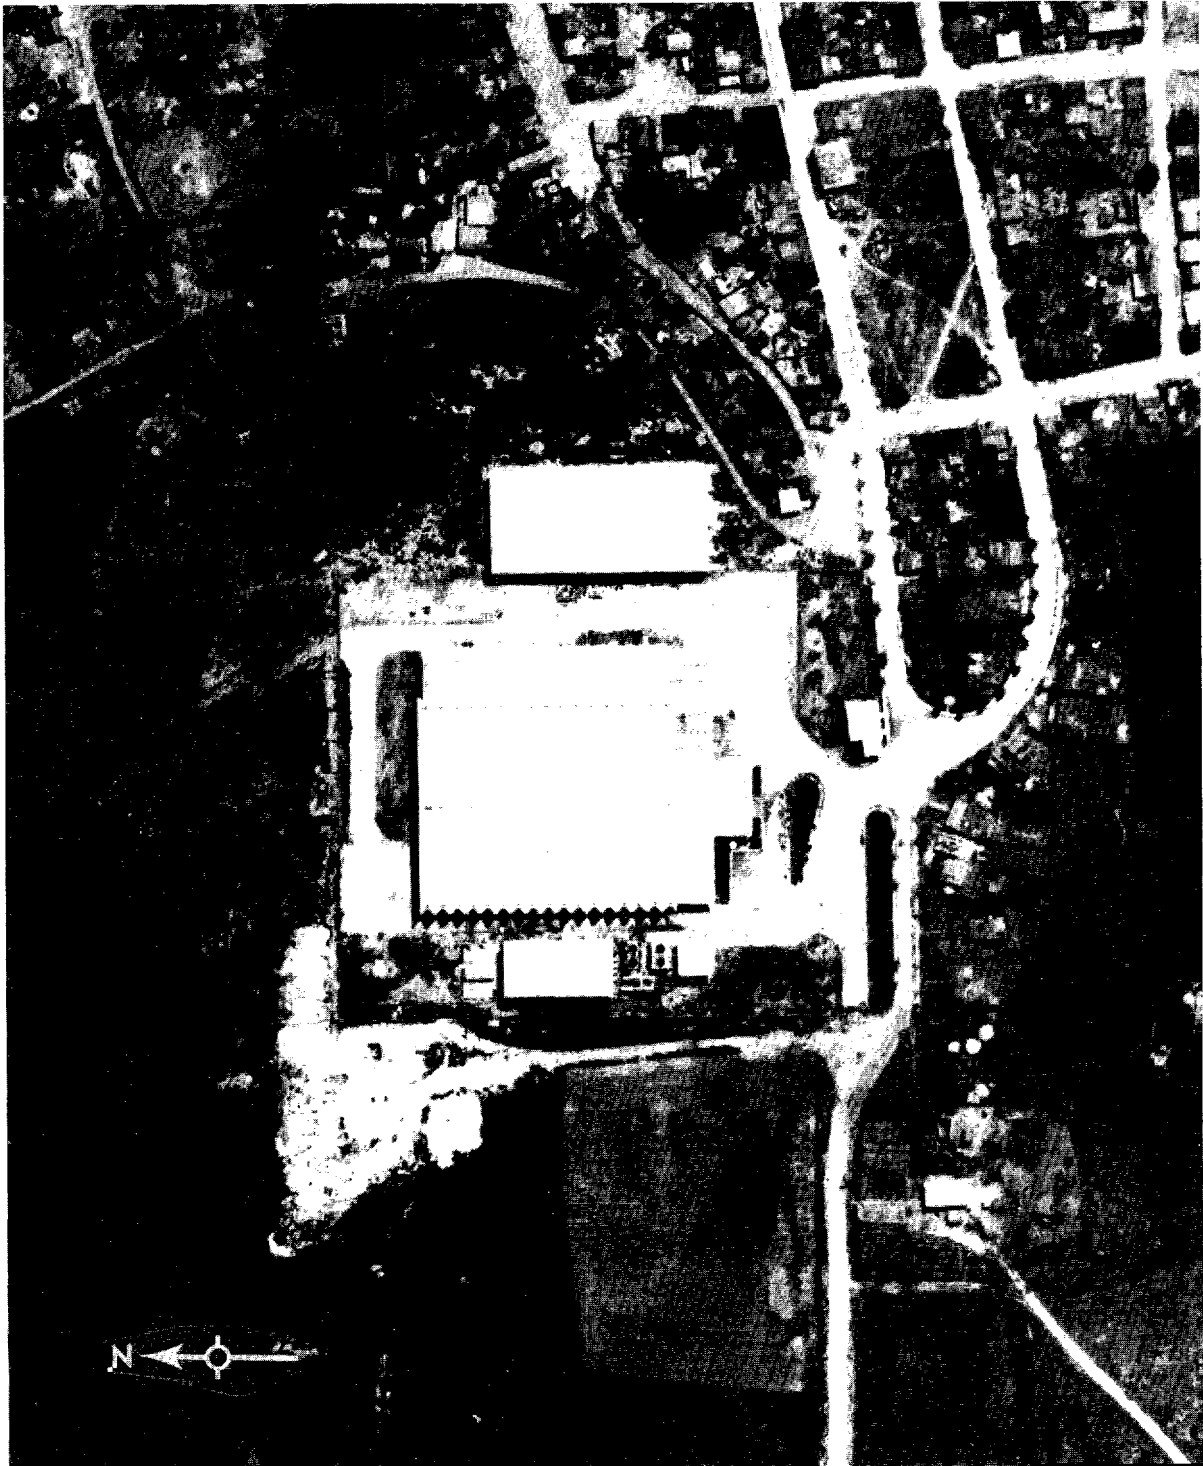
NPIC/R-1523/63
ATTACHMENT 4

NO DAMAGE OBSERVED.
(SEE ATTACHMENT 4).

INEJIRO ASANUMA SPINNING MILL
